# **Fort Leonard Wood German POW Stonework**

Maintenance and Repair

## Final report

ERDC/CERL CR-17-1 ii

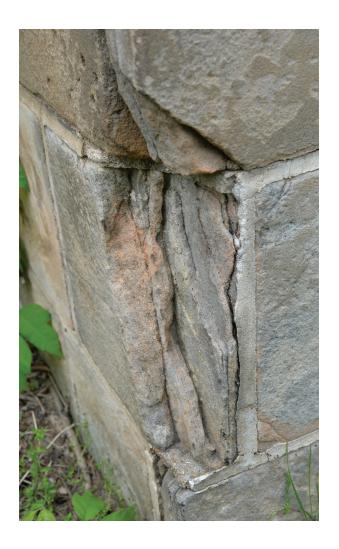
Figure 1 Delamination on the exterior of the chimney at the Black Officers Club. The stone could be consolidated, patched, or replaced depending on the decision of the site manager. If nothing is done the stone will continue to deteriorate until it is a complete loss. Photo NCPTT | Sarah Marie Jackson

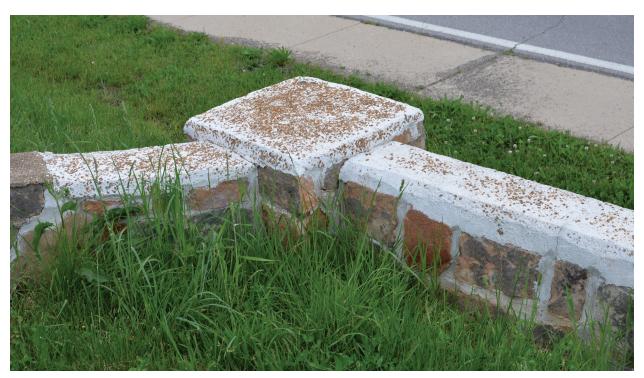
Figure 2. Repairs to the exerior wall of Rockwell Cemetery. The mix, finish, and color do not match the historical mortar. Photo NCPTT | Sarah Marie Jackson

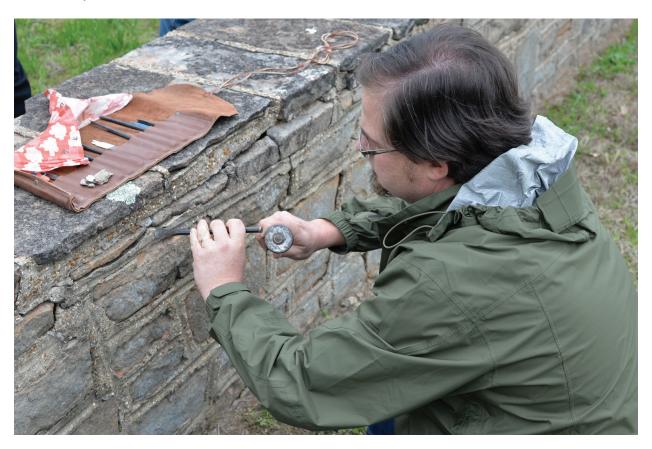
Figure 3. Jason Church removes a mortar sample from the exterior wall of Fire Baptized Cemetery. Photo NCPTT | Sarah Marie Jackson

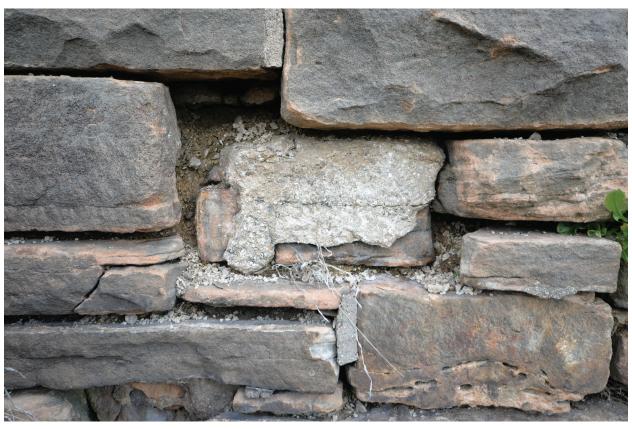
Figure 4. Deteriorated mortar and plant growth on the Constitution Ave. bridge. Photo NCPTT | Sarah Marie Jackson

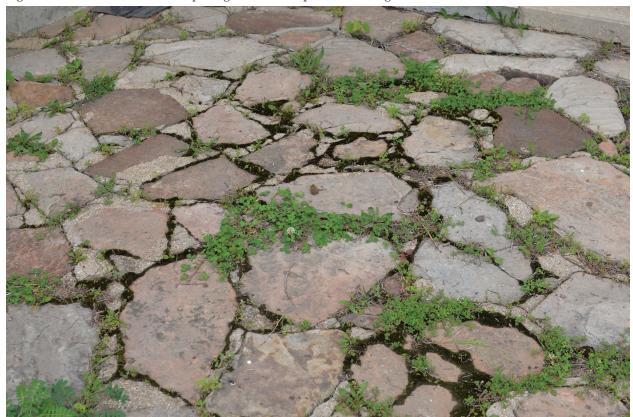
Figure 5. Deteriorated mortar and plant growth on the patio of Garlington House. Photo NCPTT

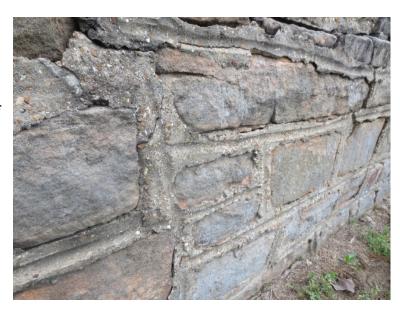
Mortar sample was removed from the interior of the stone wall surrounded Fire Baptized Cemetery. There was visible hand tooling of the mortar. The joint was solid with little to no signs of deterioration. Overall the sample was a grey appearance with a majority of small quartz aggregates mixed with some large tumbled pieces of various red hues. When the samples were sounded together they rang out sharply indicating a matrix of Portland. Due to the color this was likely Grey Portland.

This mortar was mixed and laid in the 1940's at the early days of Portland Cement's popularity. The stone used is a locally quarried sand stone. No obvious signs of incompatibility are evident with the stone or in the mortar joints.

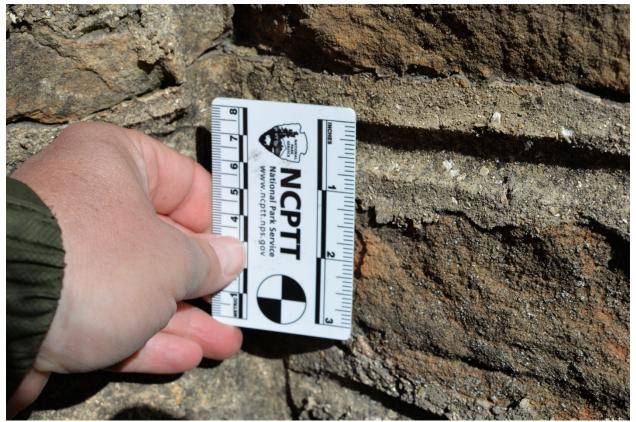
The exterior wall shows no visual structural issues at this time, although is many areas the finish mortar is deteriorated or missing. It is recommended that only the areas that are experiencing mortar failure need to be repointed and not the entire wall. The historic mortar that is in good condition needs no additional work. No obvious signs of incompatibility are evident with the stone or in the mortar joints.

If the stone is loose and the mortar is deteriorated the stone may need to be removed, cleaned and re-laid. If there repairs or not made and inspected periodically there is a chance the loose stones may fall or be taken from the site.

If there is plant growth this indicates deteriorated mortar allowing the roots to grow into the wall. These should be removed and the mortar replaced to deter additional moisture movement in the wall. Biological growth can be removed with biocidal cleaner such as D/2. This often occurs in shaded areas that take longer for the surface to dry. While it is not likely for surface biological growth to damage the structural stability some can lead to staining and does hold additional water on the surface.

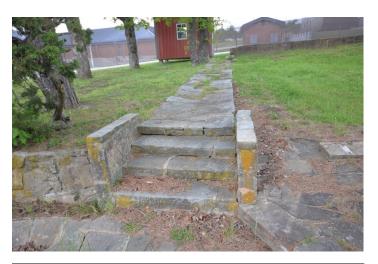
The short wall and walkways show no visual structural issues at this time, although in areas the mortar is deteriorated or missing. It is recommended that only the areas that are experiencing mortar failure need to be repointed and not the entire wall or walkway unless there is an issue with structural integrity or human safety. The historic mortar that is in good condition needs no additional work. No obvious signs of incompatibility are evident with the stone or in the mortar joints.

Biological growth and deteriorated mortar on walkways and stairs near Old Post Head Quarters.

If the stone is loose and the mortar is deteriorated the stone may need to be removed, cleaned and re-laid. If the repairs are delayed or the stonework is not inspected periodically there is a chance the loose stones may fall or be taken from the site.

Plant growth indicates deteriorated mortar allowing the roots to grow into the walkways and short walls. They should be removed and the mortar replaced to deter additional moisture

movement in the wall. Biological growth can be removed with biocidal cleaner such as D/2. This often occurs in shaded areas that take longer for the surface to dry. While it is not likely for surface biological growth to damage the structural stability some can lead to staining and does hold additional water on the surface.

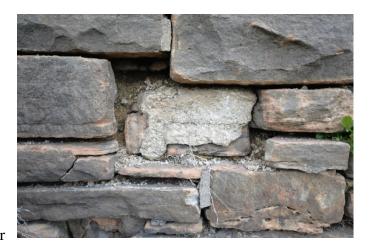
The culvert/bridge has extensive mortar failure of the stonework we inspected. If repointing and repairs are not done soon this may need complete reconstruction in the future. For many repointing projects repointing only needs to be undertaken where the mortar is failing. It is recommended that only the areas that are experiencing mortar failure need to be repointed and not the entire facade unless there is an issue with structural integrity or human safety.

The entire exterior of the culvert needs the mortar replaced. Failing mortar must first be raked from the joints. Care should be given so that the mortar is not removed more than half the depth of the stone. If mortar is failing at a greater depth consideration should be given to rebuilding the façade. No obvious signs of incompatibility are evident with the stone or in the mortar joints.

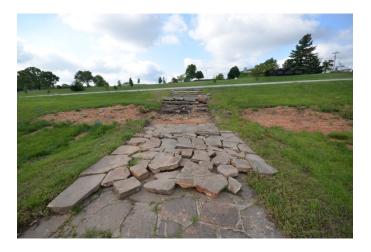
The walkways show no visual structural issues at this time, although in areas the mortar is deteriorated or missing. It is recommended that only the areas that are experiencing mortar failure need to be repointed and not the entire walkway unless there is an issue with structural integrity or human safety. The historic mortar that is in good condition needs no additional work. No obvious signs of incompatibility are evident with the stone or in the mortar joints.

If the stone is loose and the mortar is deteriorated the stone may need to be removed, cleaned and re-laid. If the walkways are going to be deconstructed for utility or site work they should be documented before any work begins. Lifting the stones out of the way and relaying them in the same pattern will assist in reconstructing the walkways.

Plant growth indicates deteriorated mortar allowing the roots to grow into the wall. These should be removed and the mortar replaced to deter additional moisture movement in the wall. Biological growth can be removed with biocidal cleaner such as D/2. This often occurs in shaded areas that take longer for the surface to dry. While it is not likely for surface biological growth to damage the structural stability some can lead to staining and does hold additional water on the surface.

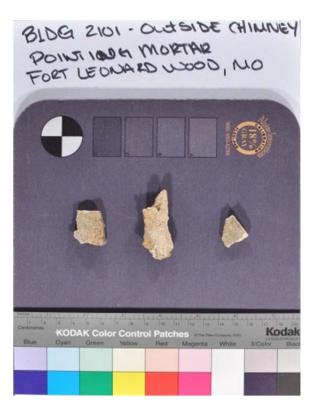
This report is for Sample 2101 which was removed from the lower exterior part of the chimney of Building #2101 (See lower picture on page 2). From the photograph it shows that this joint was solid with little to no signs of deterioration.

This mortar was mixed and laid in the 1940's at the early days of Portland Cement's popularity. The stone used is a locally quarried sand stone. No obvious signs of incompatibility are evident with the stone or in the mortar joints.

Sample 2101 was three separate pieces all ¼" thick (size of the mortar joint). The largest piece was 1 7/8" x 3/4". Overall the sample was a white matrix with buff and red aggregates all fairly small. When the samples were sounded together they rang out sharply indicating a matrix of Portland. Due to the color this was White Portland.

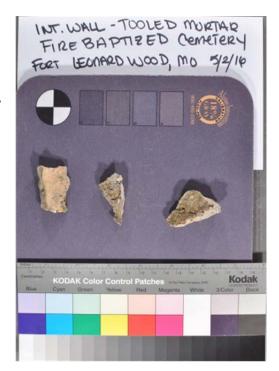
This report is for Sample Fire Baptized Cemetery, Interior Wall Tooled Mortar which was removed from the stone wall surrounding the Fire Baptized Cemetery (See lower picture on page 2). From the photograph it shows that this joint was solid with little to no signs of deterioration.

This mortar was mixed and laid in the 1940's at the early days of Portland Cement's popularity. The stone used is a locally quarried sand stone. No obvious signs of incompatibility are evident with the stone or in the mortar joints.

Sample Fire Baptized Cemetery, Interior Wall Tooled Mortar was seven separate pieces. The largest piece was 1 1/2" x 1"x 3/8". One side of the largest piece is uniformly pink, this is due to it bonding with the surrounding stone and removing the stone when the joint failed. Overall the sample was a grey appearance with a majority of small quartz aggregates mixed with some large tumbled pieces of various red hues. When the samples were sounded together they rang out sharply indicating a matrix of Portland. Due to the color this was likely Grey Portland.

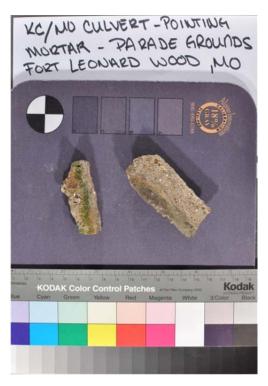
This report is for Constitution Avenue Bridge at Parade Grounds, Pointing Mortar which was removed from the stone culvert lining the canal on the corner of Kansas and Missouri roads. (See lower picture on page 2). From the photograph it shows that the joints were washing out as the mortar begins to fail.

This mortar was mixed and laid in the 1940's at the early days of Portland Cement's popularity. The stone used is a locally quarried sand stone. No obvious signs of incompatibility are evident with the stone or in the mortar joints.

Sample Constitution Avenue Bridge at Parade Grounds, Pointing Mortar was in two large separate pieces. The largest piece was 3" x 1"x 1". The samples have a concave tooled shape to the side that was exposed. This shows that the joints of the culvert all had a concave tooled shape. Overall the sample had a buff appearance with a mix of red hued aggragates. When the samples were sounded together they rang out sharply indicating a matrix of Portland. Due to the color this was likely White Portland.
